Sløvågen Gulen Substation – Rock Fall Risk Assessment

Prosjekt:	Sløvågen_Gulen Substation Bergsikring	Prosjektnr.:	10241238
Kunde:	Wergeland Base AS	Prosjektleder:	Felix Kluge
Utarbeidet av:	NOFELI	Dato:	22.02.2024
Kontrollert av:	NOROAN		
Dokumentnr.:	Nr 1	Rev.:	0

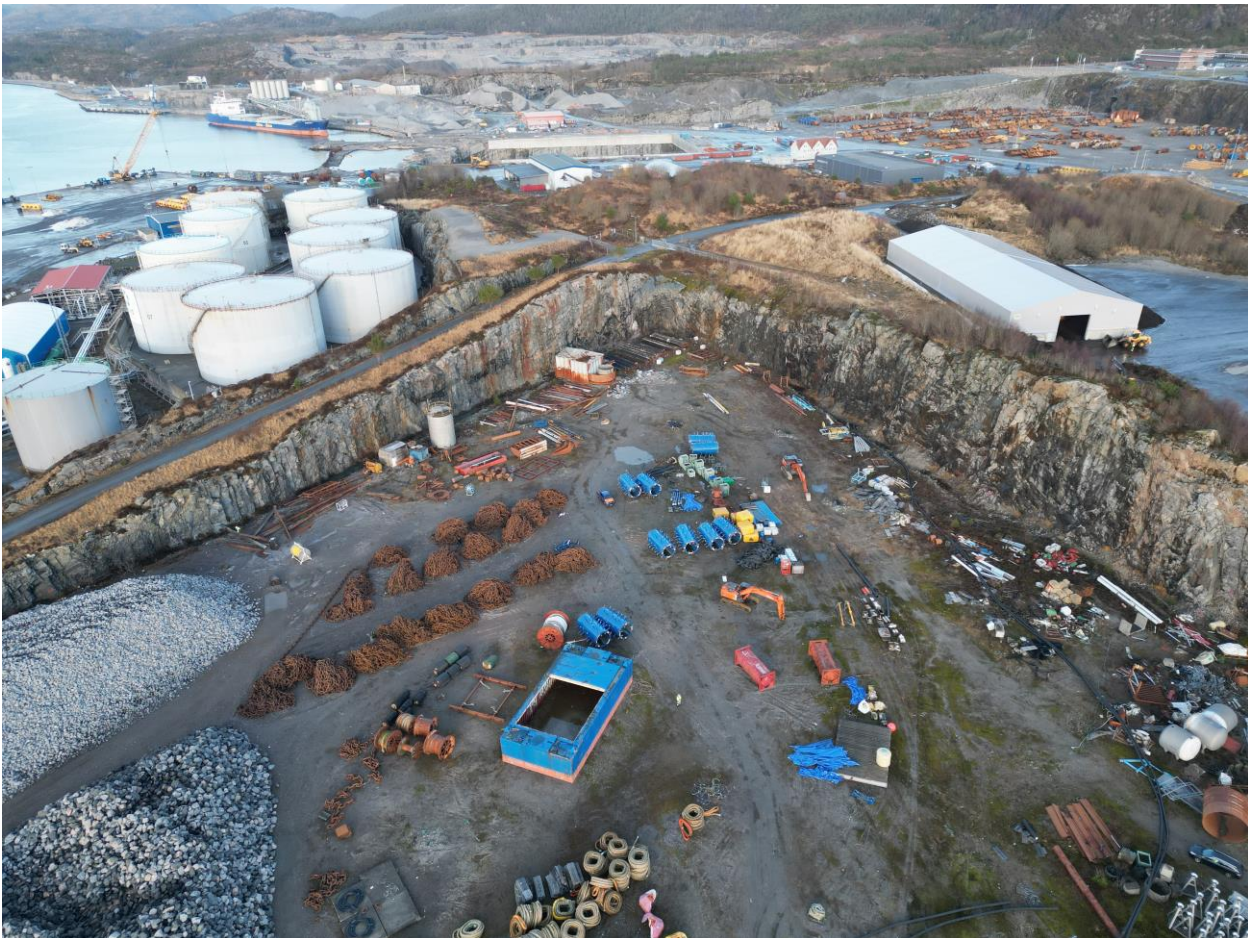
Figure 2 Drone photograph giving an overview of the site

A site visit was conducted on the 25.01.24 by the engineering geologists Felix Kluge and Stig Vevatne, together with Jonathan Mechineau from GE offshore wind (Figure 2, drone overview of the site).

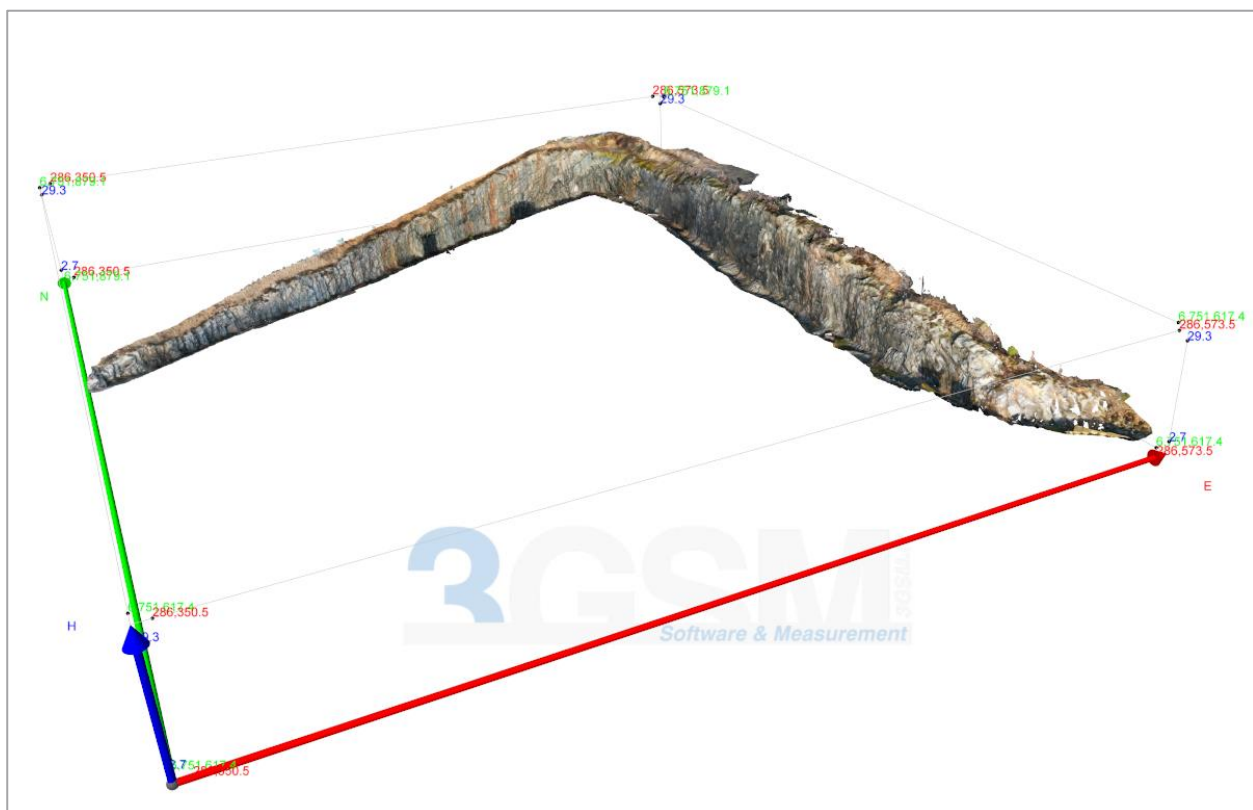
Figure 3 Digital outcrop model produced using photogrammetry

A digital outcrop model was constructed (Figure 3) using the software Shape matrix with 1200 drone photographs covering the rock cuts in the east and northwest. The model has an average point spacing of 7 cm and an estimated precision of 13 cm. Discontinuities are mapped manually using the shape matrix analyst tool.

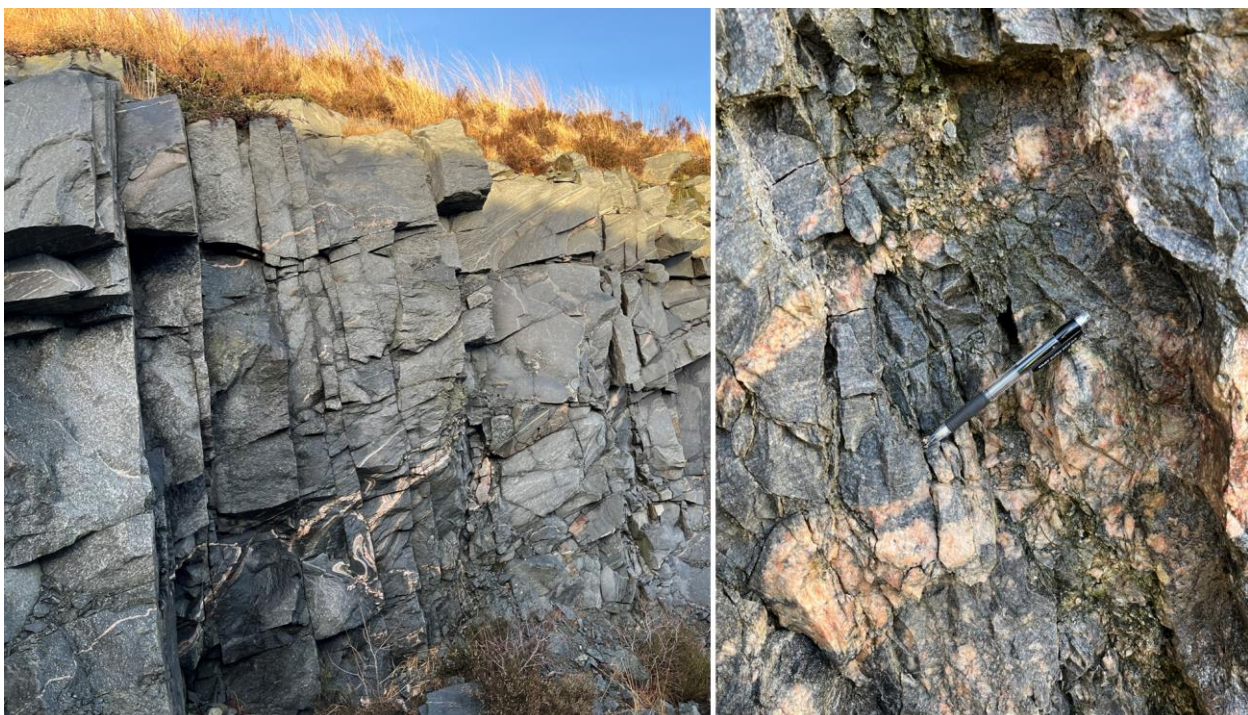
Figure 4 Showing typical appearance of the rock mass

The rock type observed at the site is a high-grade metamorphic migmatite gneiss, predominantly dark gray with characteristic tightly folded bands rich in pinkish feldspar. This agrees with the bedrock map published by NGU, which displays a northwest-southeast striking formation of migmatite gneiss protruding through the area [5]. Pictures of the rockmass are showed in Figure 4 and a bedrock map in Figure 5.

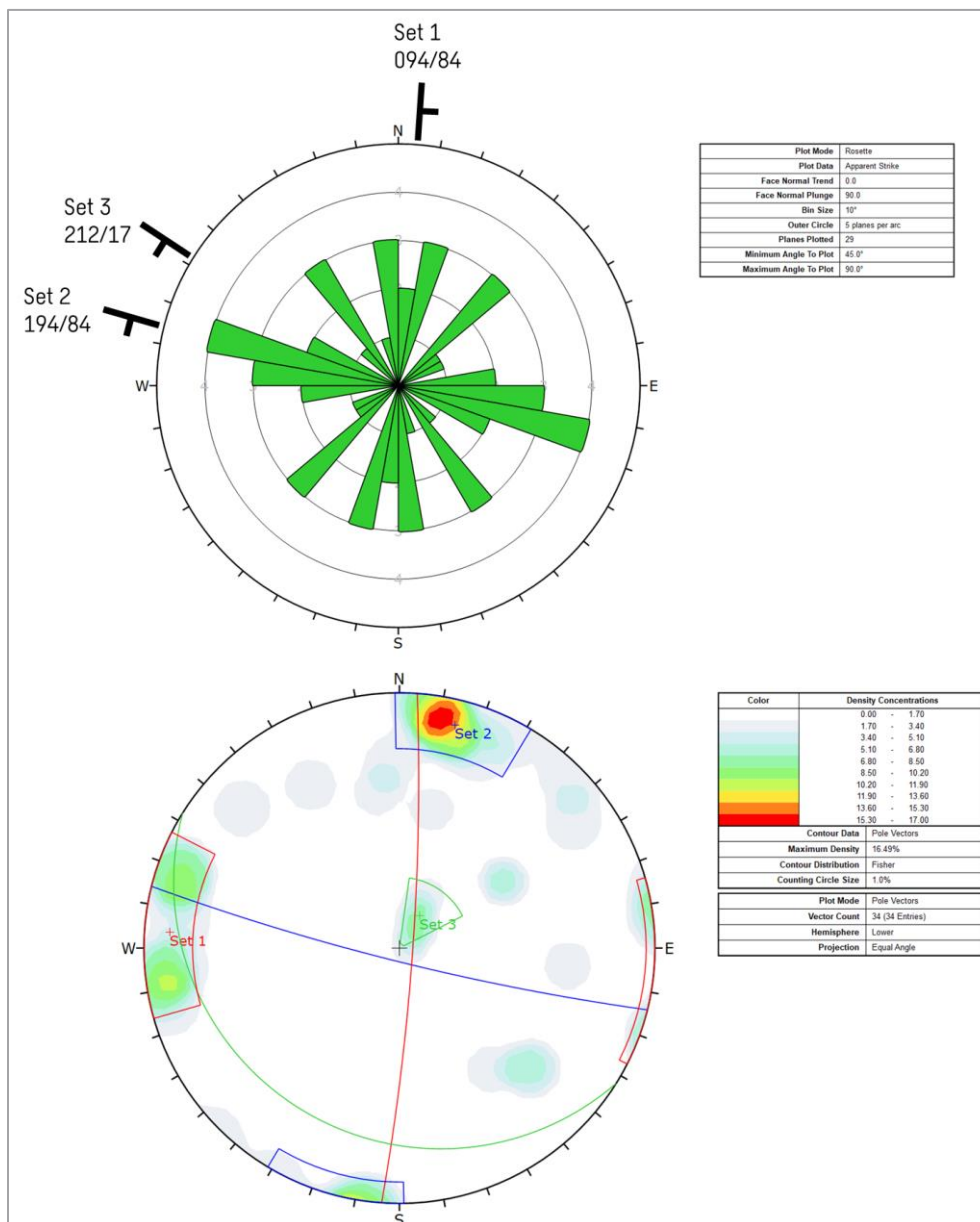
Figure 6 Stereographic projection and rose diagram showing discontinuity measurements collected with compass and clinometer

The rock mass is characterized by a varying degree of jointing. Three main joint sets are distinguished as well as abundant joints with seemingly sporadic orientations. Joint sets are described in Table 6 and shown as a stereographic projection and rose diagram in Figure 6.

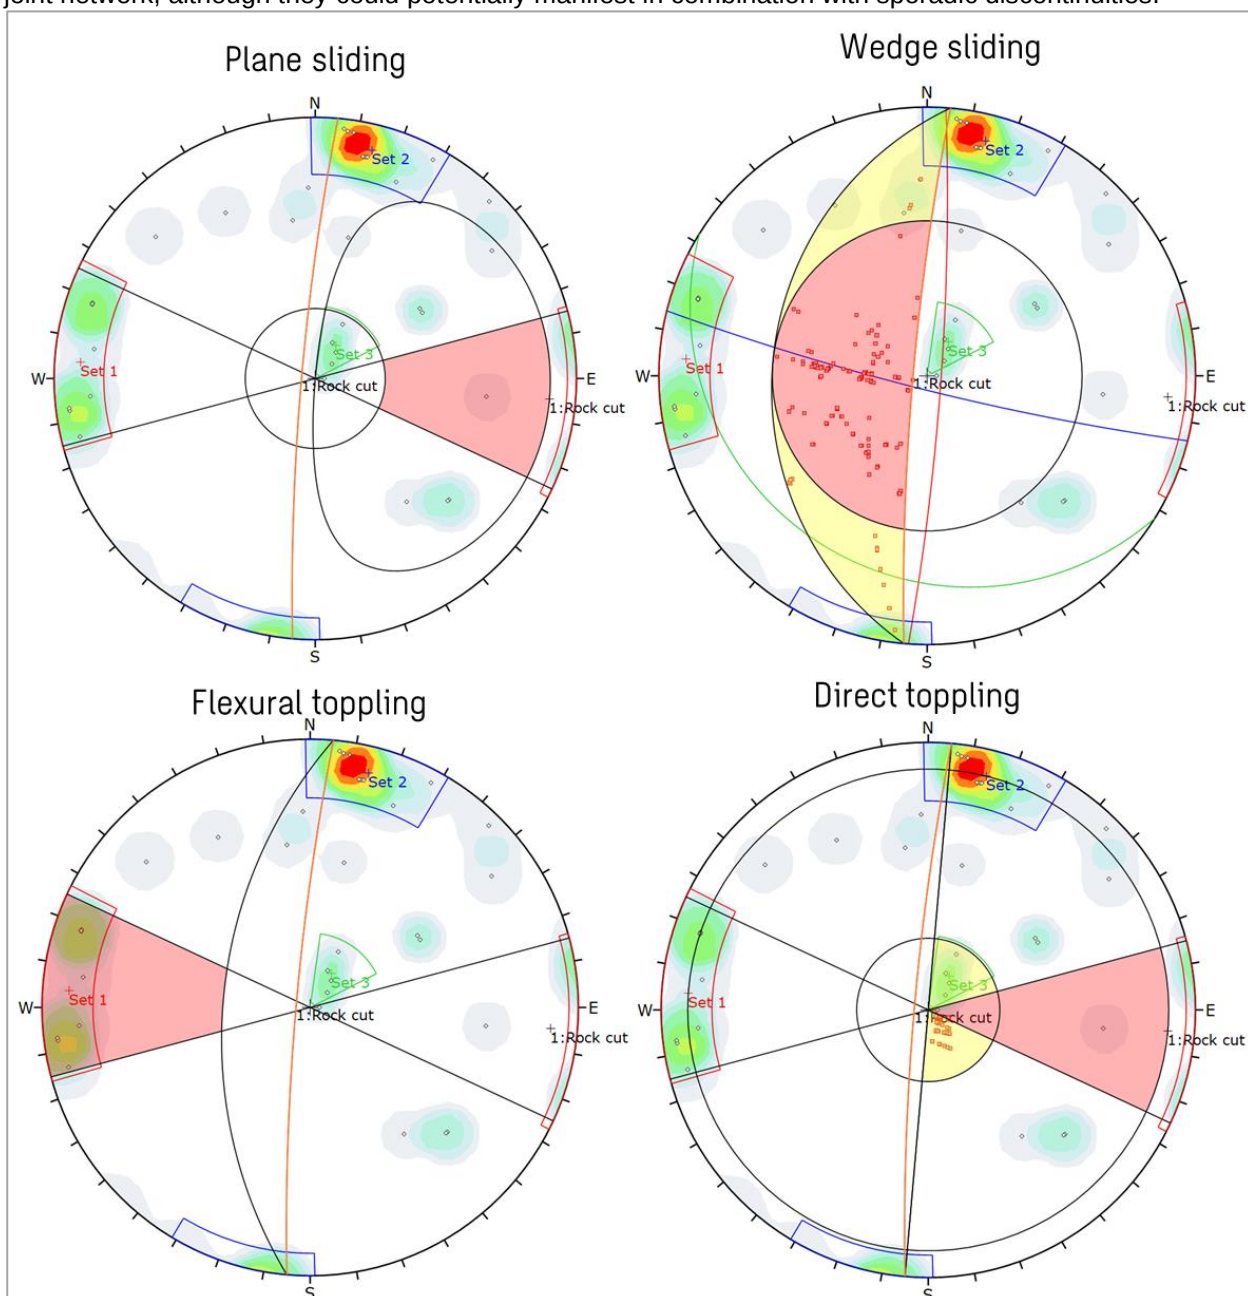
Figure 7 Kinematic analysis for the rock face closest to the planned facility

A kinematic analysis for the rock face closest to the planned facility is performed using joint orientation measurements from the site (Figure 7).

The analysis indicates that the systematic joint network can facilitate toppling as a probable failure mechanism. Planar sliding and wedge sliding are deemed unlikely to occur solely due to the systematic joint network, although they could potentially manifest in combination with sporadic discontinuities.

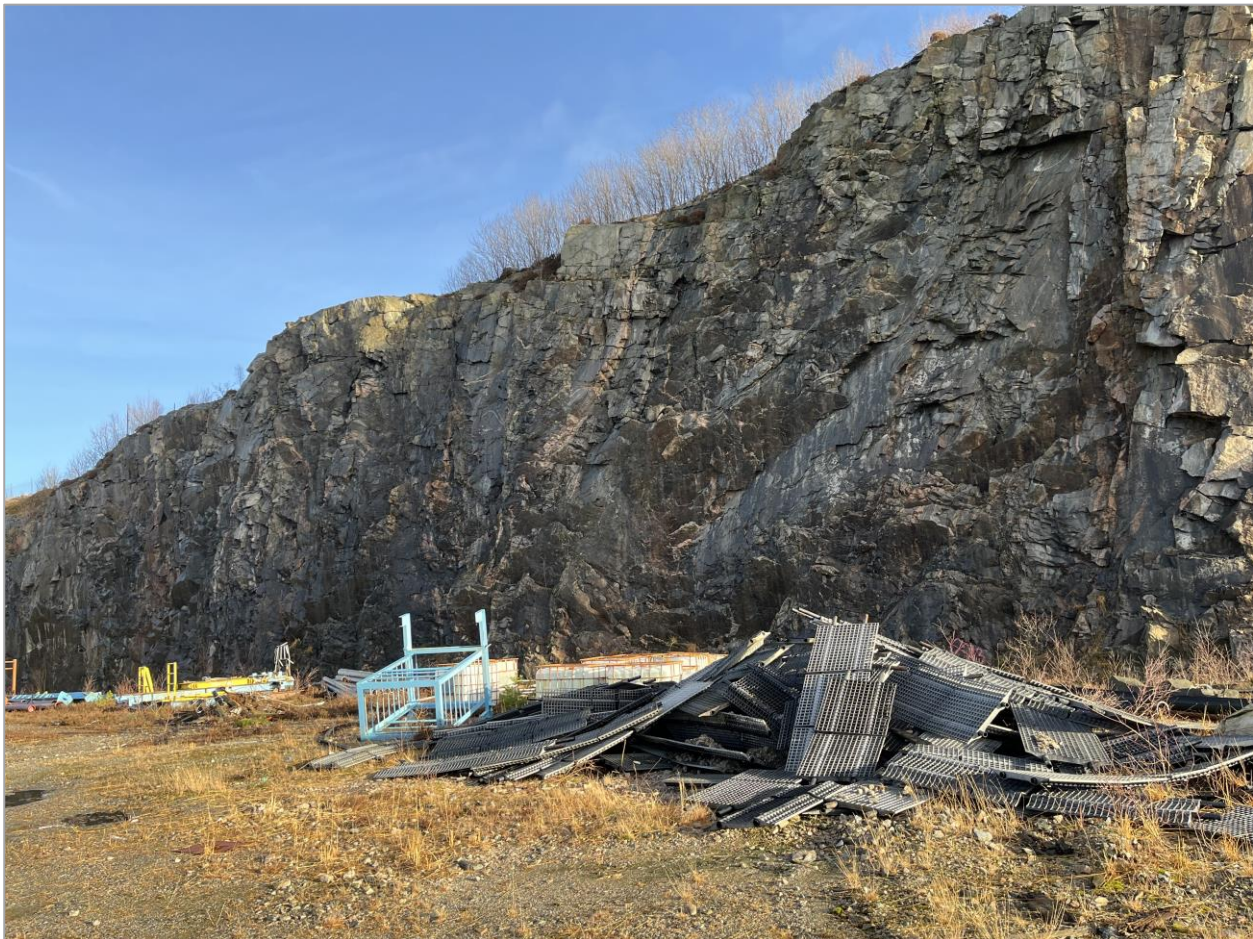
Figure 8 View of the large-scale rock wedge

Along the southernmost section of the facility, a significant wedge-shaped structure is evident (Figure 8 and Figure 9). Below, it is bounded by a distinct joint, oriented at 280/79 (Joint 1). While the joints delineating the structure to the north are less defined, several intermittent fissures related to joint set 2 may intersect with joint 1. A potential joint, indicated by a faint trace, is estimated to have an orientation of 208/84 (Joint 2). At its peak the structure is ca. 15 m high and comprises a volume of ca. 300 m³. Based on stability analyses with the software Swedge, it is found to be very unlikely that the structure would be stable based only on joint roughness (friction), suggesting stability is governed by rock bridges and/or cohesion. Based on the model, it appears that joint 1 terminates just before reaching the intersection, leaving some uncertainty regarding the complete delimitation of the rock volume. Rock bridges near the intersection between joint 1 and joint 2 may currently be preventing the structure from failing, but it's possible they could deteriorate over time due to weathering, potentially leading to future instability.

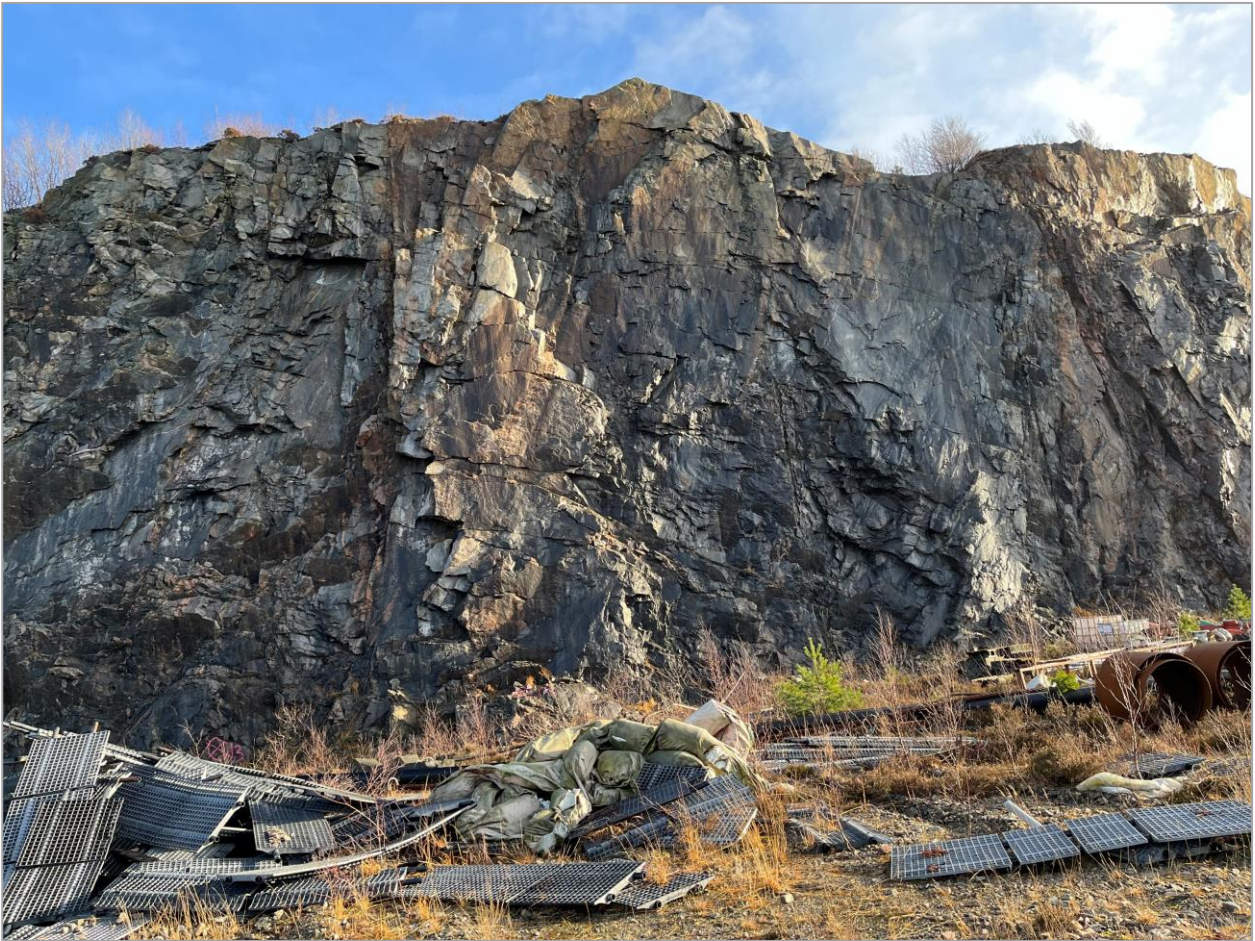
Figure 10 View of a potentially unstable rock column

Another potentially unstable rock mass is identified to the south of the planned facility. This mass, resembling a vertical column of ca 16 m height (ca 80 m³), delimited by vertical joints oriented approximately 088/88 (Figure 11). Steep joints dipping slightly into the rock face, coupled with gently

inclined to sub-horizontal fissures intersecting the structure, suggest that the structure might be prone to toppling.

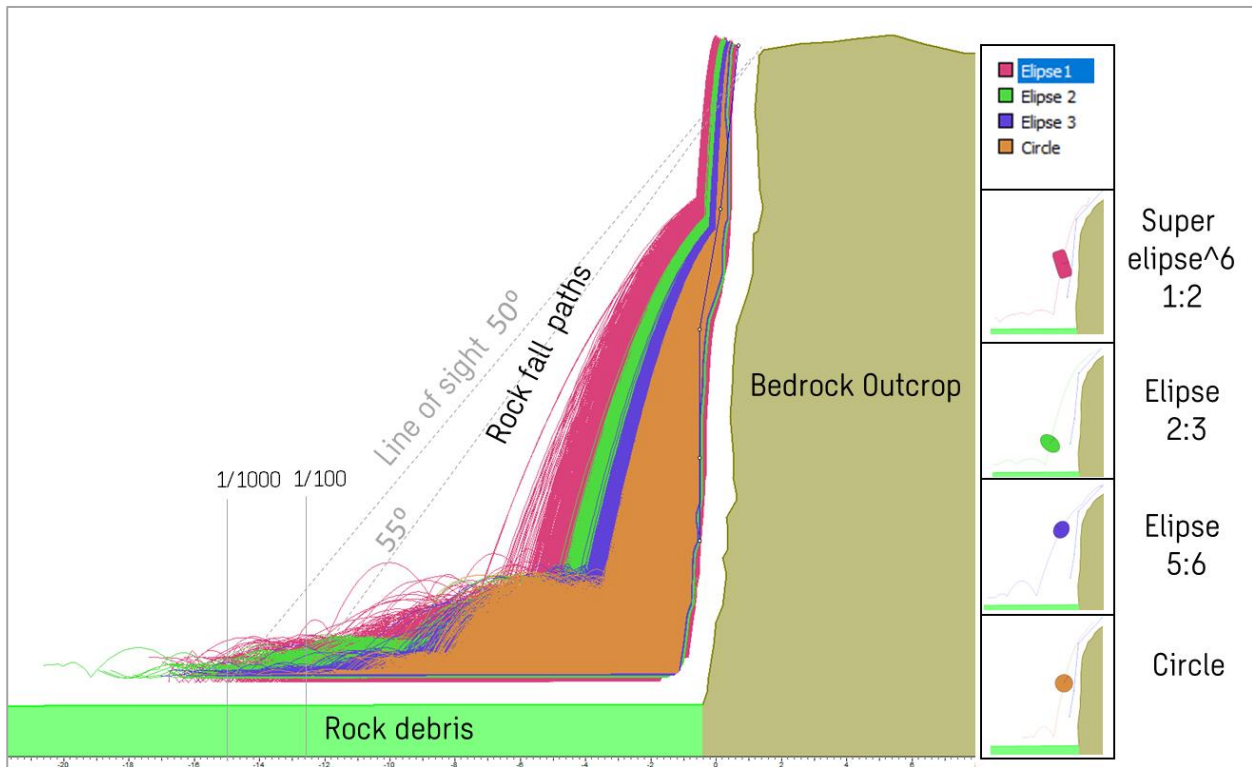
Figure 12 Example of profile analyzed with Rocfall (profile P3). Approximate S1 and S2 boundaries are shown annotated 1/100 and 1/1000 respectively. Rockfall paths are color coded according to four different rock shapes considered. All rock shapes are dimensioned as such that they measure 15000kg (2D shape). For Elipse 1 this corresponds to an approximate size of 3.5*1.5*1 m.

The Rocfall software by Rocscience was used to evaluate the reach extent of fragments falling from the rock face, bouncing off it, and rolling along the gravel surface (Figure 12).

The endpoint distance from each profile was used to guide the definition of two lines, defining the boundaries for the S1 and S2 risk zones (Figure 12 and Figure 13). The equivalent sight angle for the S1 varies between 40 – 55° (average 45°) whilst the angle varies between 35 – 50° for S2 (average 40°) (Table 7).

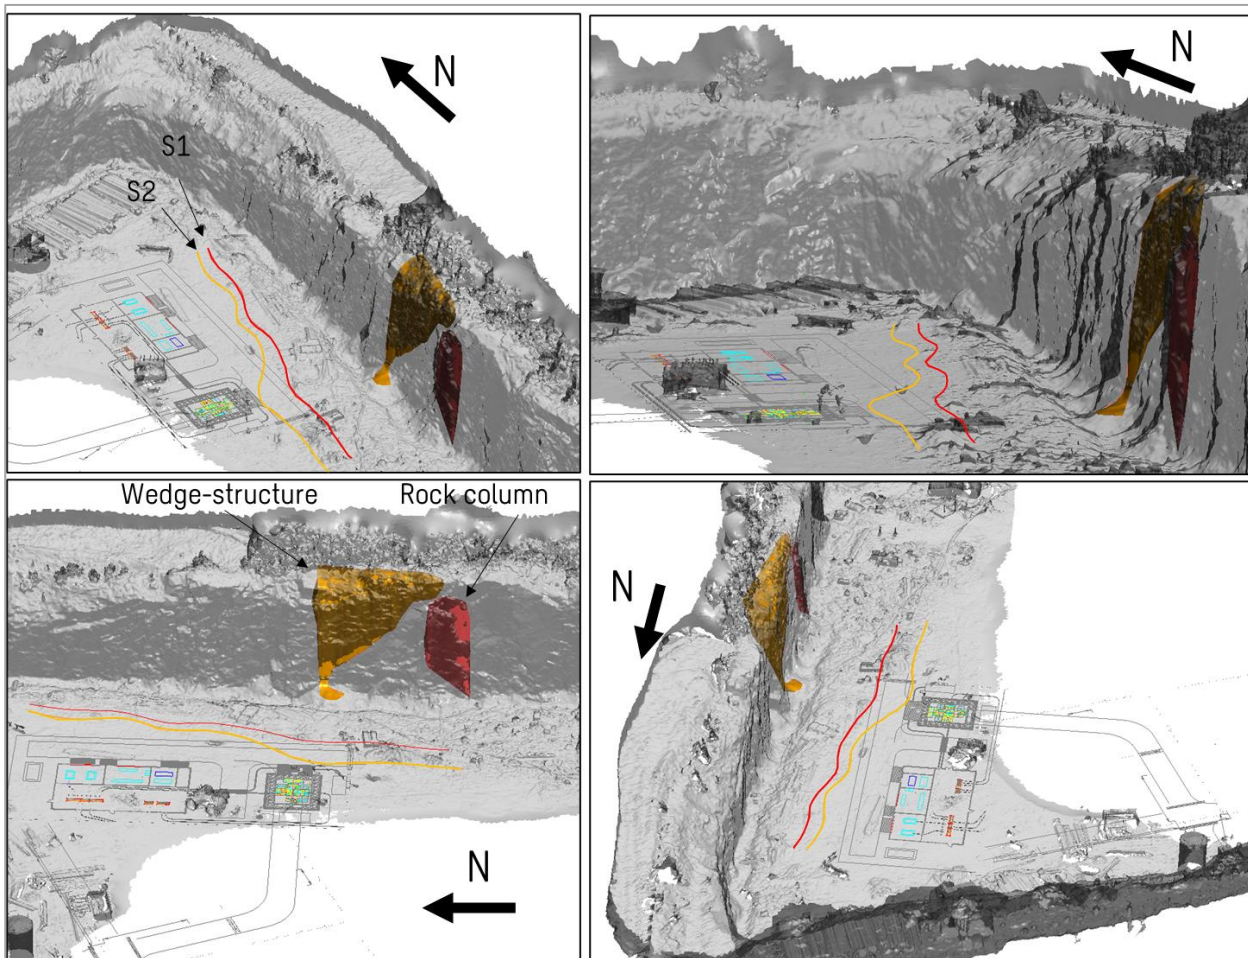
Figure 14 3D Perspectives showing the planned facility in relation to the S1 and S2 line as well as the potentially unstable large-scale rock wedge (orange) and rock column (red).

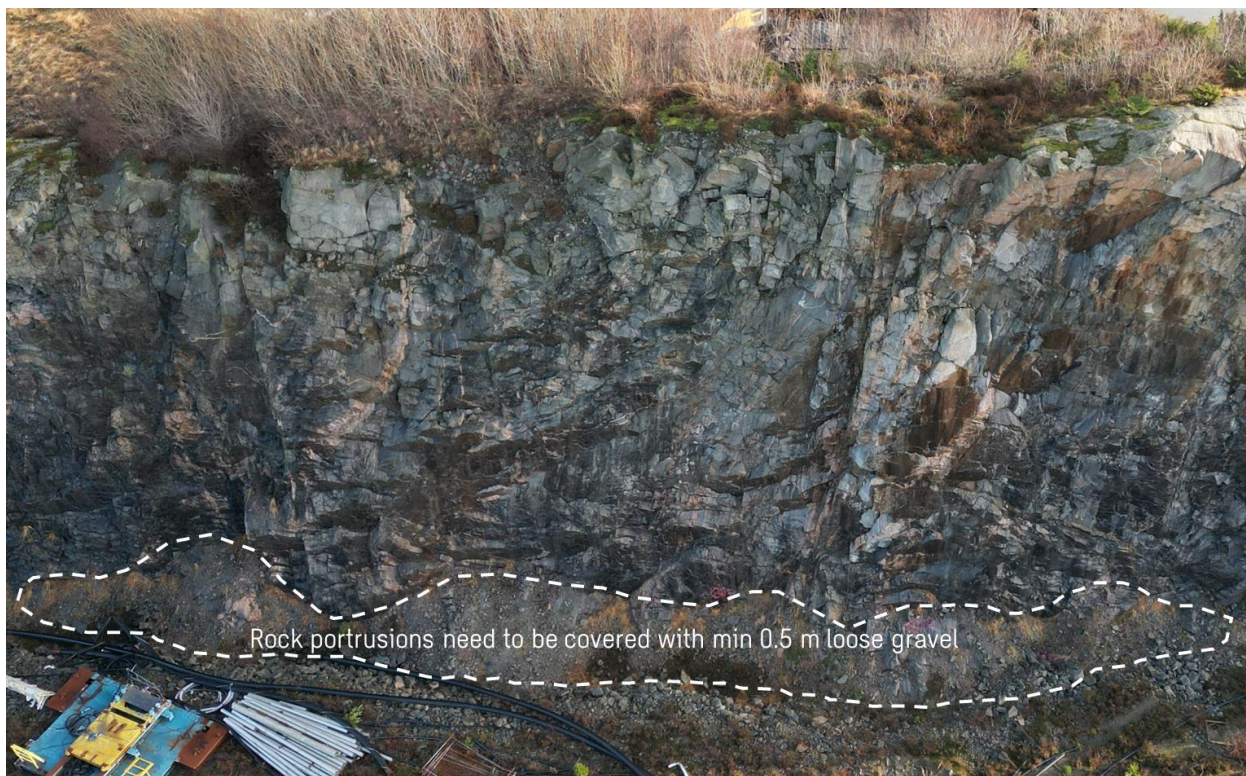
Figure 15 Exposed rock protrusions along the base of the rock cut need to be covered with energy absorbing material e.g. min. 0.5 m of loose gravel.

Substation structures are drawn to lay outside of the S2 zone and satisfy thereby the requirements of S2 with a nominal annual risk $< 1/1000$, whilst the road satisfies the requirements of S1 with a nominal annual probability $< 1/100$. The demarcation of the lines presupposes that rock protrusions at the base of the rock face are covered with loose gravel e.g. 32- 64 mm fraction with min. 0.5 m thickness (Figure 15). The thicker the gravel cover the greater the expected energy absorption. When this is fulfilled, there is no immediate necessity for the installation of mitigating construction measures such as rock bolts.
